PROTECTIVE COATINGS APPLICATION

FUSION™ GUN REDUCES POLYUREA CONTRACTOR'S MAINTENANCE & REPAIRS

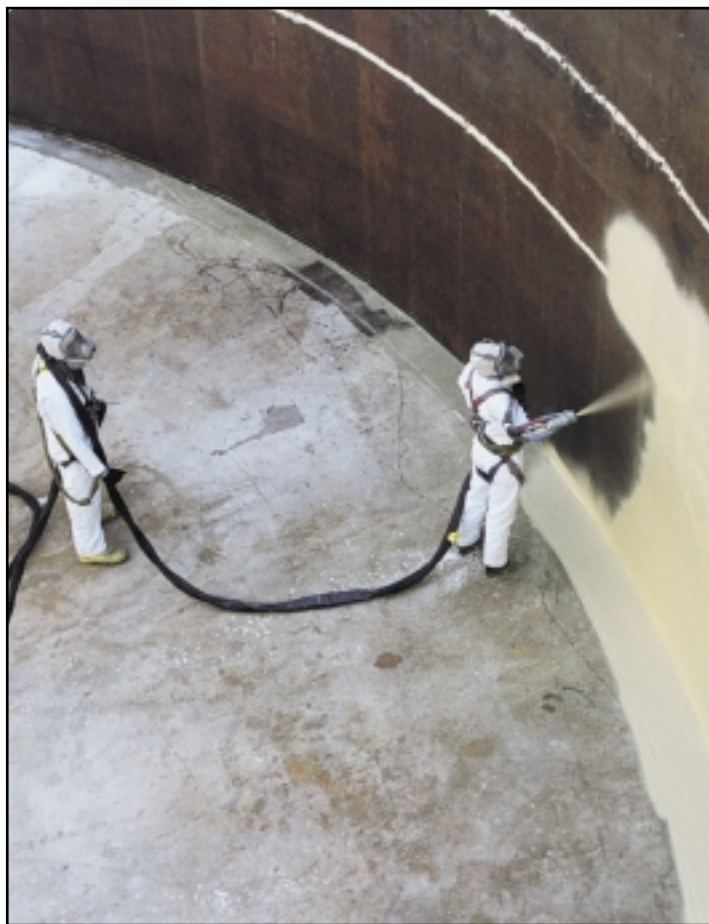
Graco's Reactor™ proportioner, heated hose and Fusion™ spray gun allowed B & H Coatings to increase production and reduce maintenance.

The proportioner and polyurea are kept in the crew's temperature controlled work trailer. Graco Monark® low-pressure feed pumps transfer the resin and isocyanate (ISO) from 55-gallon drums to the Reactor proportioner. In addition to

proportioning the resin and ISO, the Reactor's electronics provide diagnostic, data reporting, pressure readout, temperature and pressure controls, as well as auto-shut down capabilities to assure the system performs to B & H's and the material supplier's specific requirements.

From the proportioner, precise ratios of resin and ISO are pumped through 300 feet of heated hose to the spray gun. The hoses maintain the polyurea's temperature between 160°-170° F. “It takes only about 20 minutes to bring the material to this temperature when we start up each morning,” says Crew Supervisor Frank Wallace. “Then this temperature is maintained the entire day.”

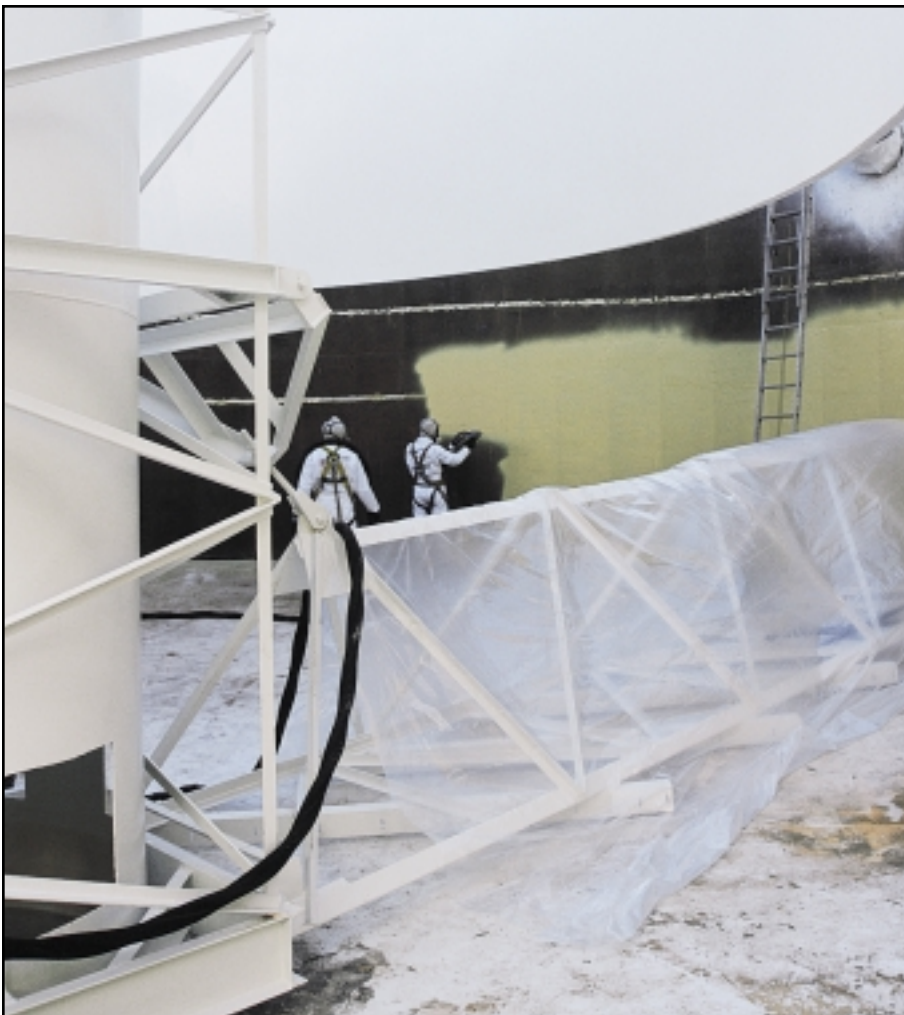
The gun's feature that eliminated this problem is the new patented

Air-Shot™ air cap that provides an extra blast of air across the orifice. The air stream reduces build-up around the tip's orifice where clogging typically occurs.

Polyurea was also tough on the seals of Calloway's old gun. He was replacing these seals daily. The Fusion gun's new rugged stainless steel side seals have reduced this chore to a once-a-month event. Again, increasing production. The fact that no tools are required to tear down the gun also reduces downtime related to gun maintenance.

Another feature that saves Calloway time is the gun's patented Quick Shot™ grease port. At the end of the day, he simply shoots grease into the head of the gun, coating the entire fluid section to prevent moisture exposure. It takes only a couple of seconds and assures the gun is ready to spray the next day. "At the end of each day I had to take the gun apart to clean the mixed polyurea out of the spray tip, mix chamber and seals. It took me at least a half-an-hour," he said.
